# 6 MAINTENANCE AND PRESERVATION OF CONCRETE STRUCTURES.

Report 2

## REPAIR OF EROSION-DAMAGED STRUCTURES,

11 April 1980

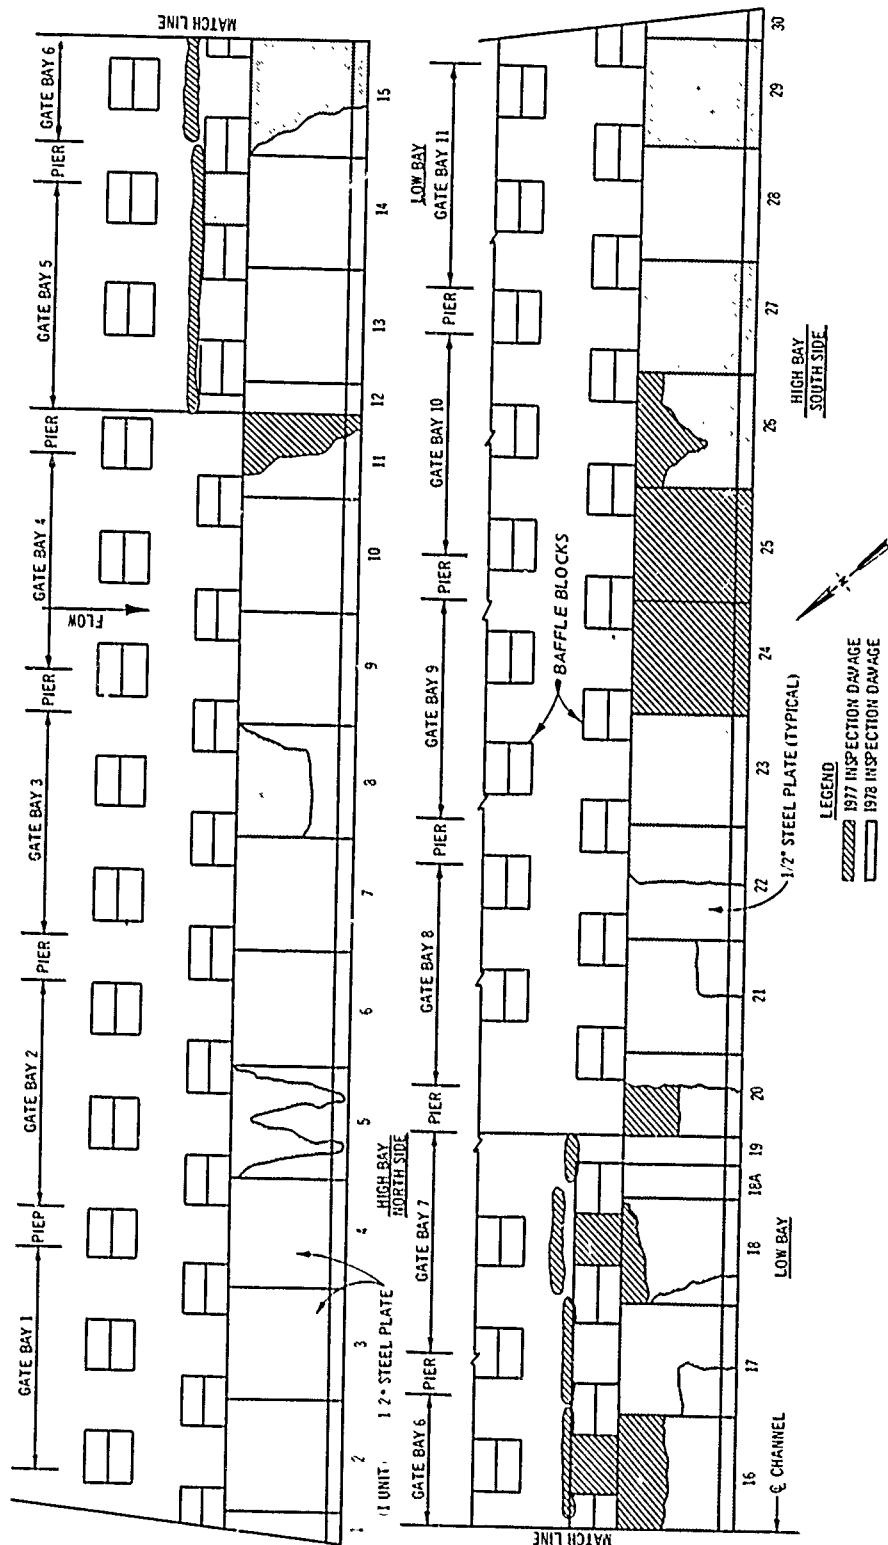
23. Damage to the stilling basin repairs was generally confined to loss of some of the steel plating from the modules used to form the voids for placement of the grout (Figure 10). Seven of the 30 module plates and all six of the flat plates sustained varying degrees of damage. All spoilers were missing. In those areas where steel plating was lost, the exposed grout surface showed no evidence of erosion. The loss of the structureward one third of the plate of module 16 and its associated flat plate revealed that no grout had been placed under the flat plate and that grout had not entirely filled the void between the

Figure 10. Damage to stilling basin repairs, Old River

top plate of the module and the stilling basin slab. Portions of the plates in modules 11, 18, 20, 24, 25, and 26, ranging from about 20 to 100 percent, were lost. A number of anchor bolts were found broken either flush with the module plate, flush with the grout, or pulled completely out.

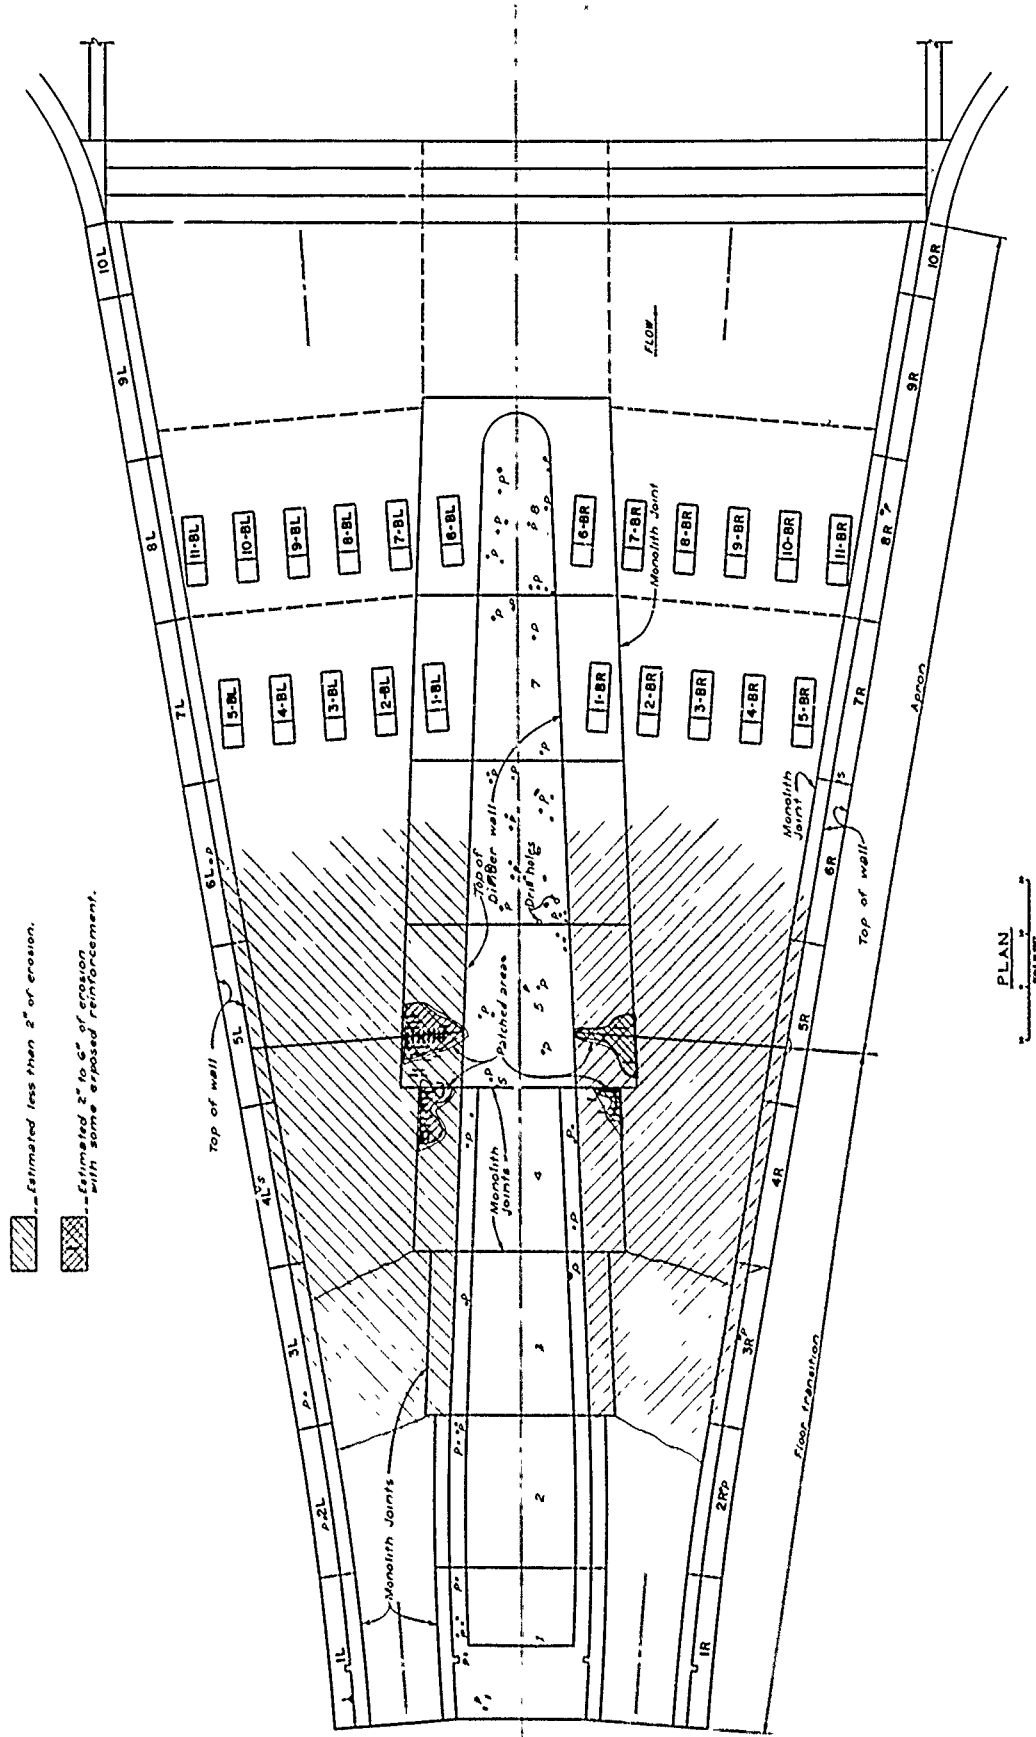
Figure 38. 1973 erosion damage, Tuttle Creek Dam

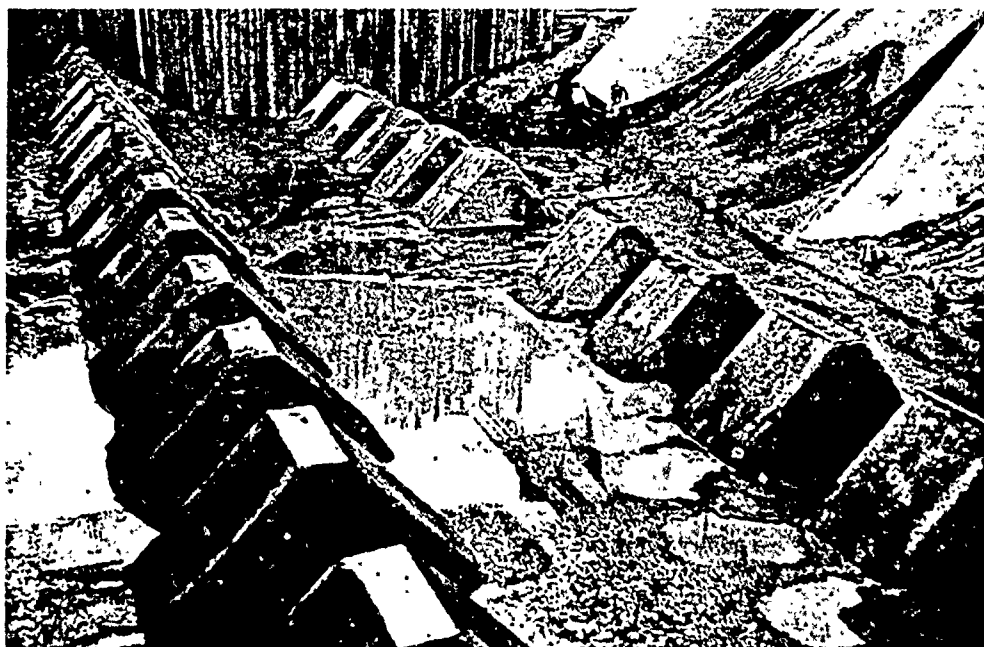
a. Baffle and deck erosion

b. Pier nose and apron erosion

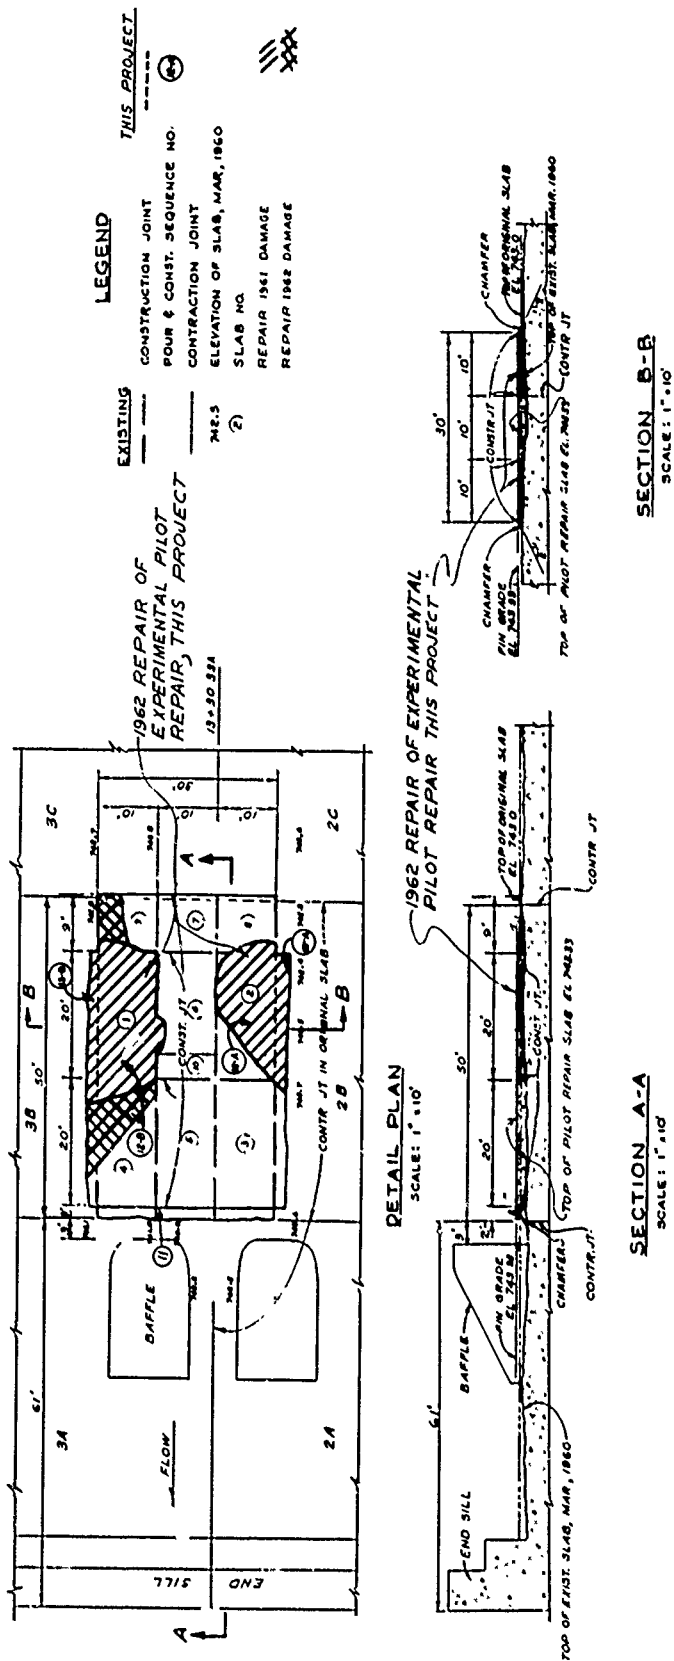
140. The second inspection of the experimental repair slab in November 1962 (Seattle District 1963) revealed that additional damage had occurred since the first inspection of November 1961. This damage occurred in sections 4 and 9 and amounted to approximately 50 and 35 sq ft, respectively (Figure 76). The eroded concrete surface of the original stilling basin floor was exposed in these areas, indicating an apparent bond failure of the repair concrete. This damage was similar to that found after the first year of exposure to spillway discharge. The maximum and average discharges during 1962 were 300,000 and

Figure 76. November 1962 inspection and repair of experimental pilot repair, Chief Joseph Dam (from Seattle District 1963)

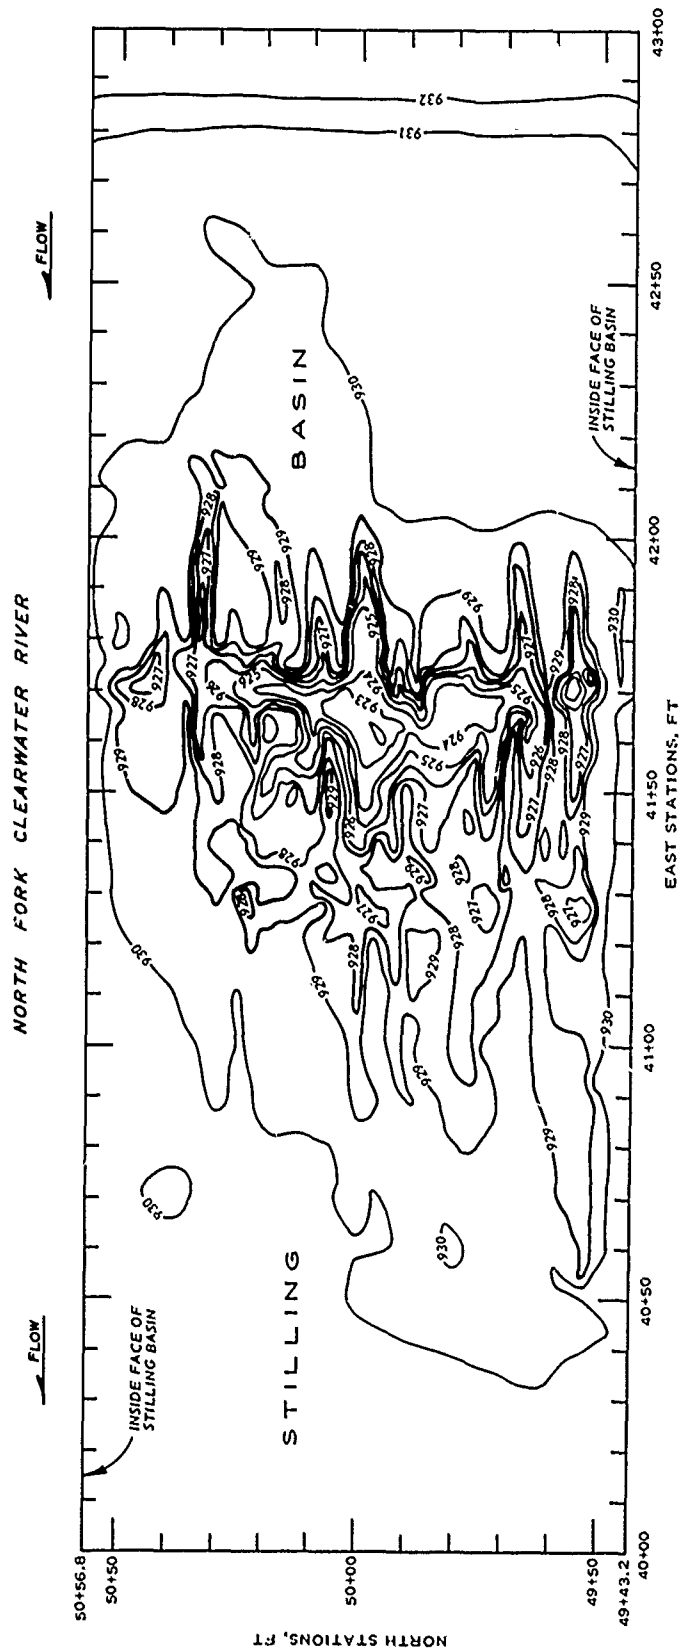
Figure 107. Survey of stilling basin damage, Dworshak Dam  
(from Walla Walla District 1975a)

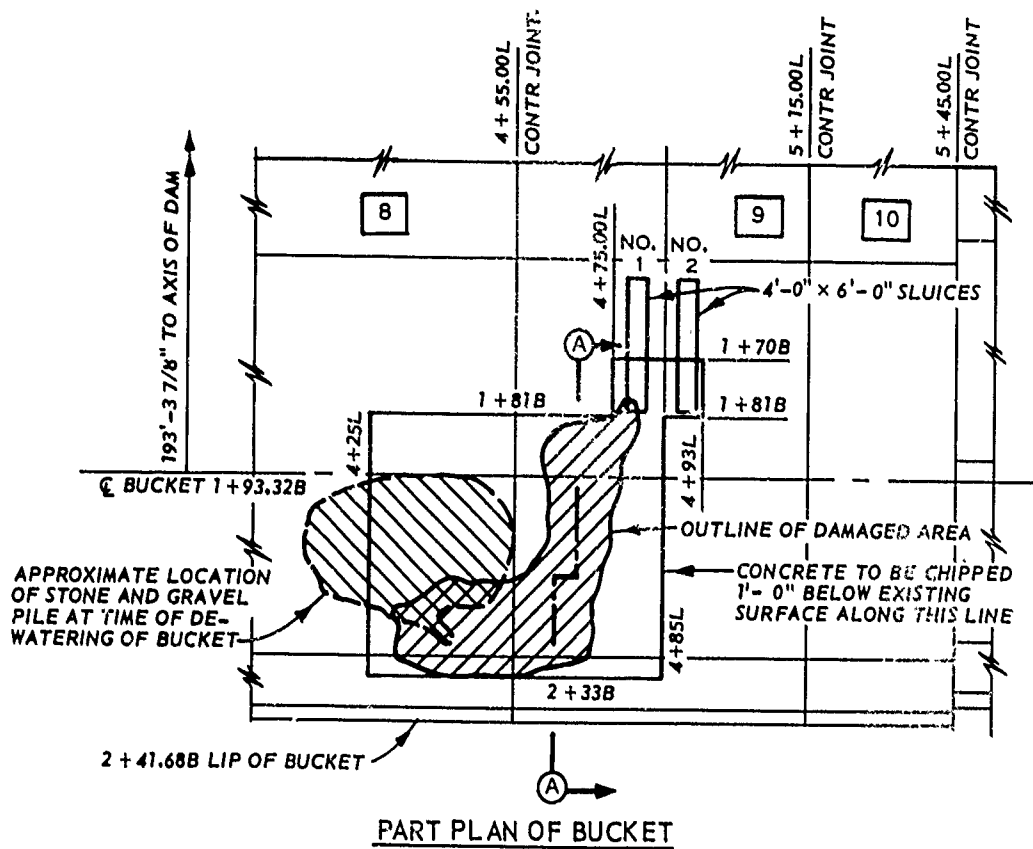
- a. The erosion at the sluice outlets was the result of the combined action of cavitation and impact of large boulders being moved about by the swirling action of the water in the bucket. It was agreed that the design of the sluice outlets could have been improved by using rounded or splayed corners instead of square ones.

Figure 134. Extent and location of erosion damage, Center Hill Dam

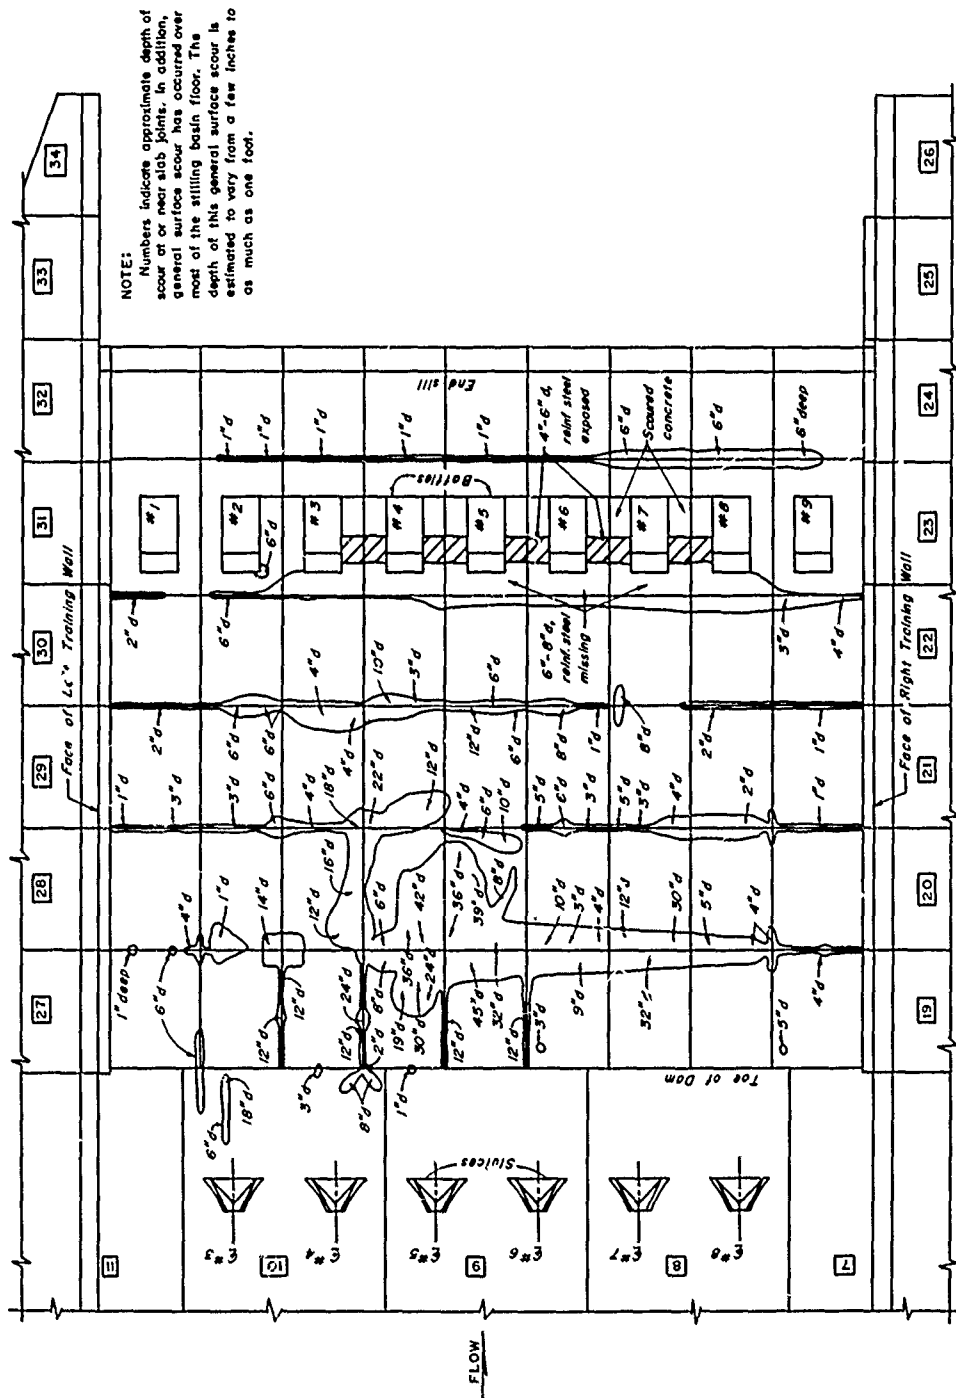
253. Damage to the stilling basin floor was most noticeable in the area downstream of sluices 4 and 5 (Figure 138). The two rows of slabs adjacent to the left training wall had generally minor surface erosion with a maximum depth of approximately 6 in. A large, donut-shaped hole (Figure 139) extended over four slabs downstream of sluices 4 and 5 and had a maximum depth of about 42 in. Erosion was generally deeper at the joints. Damage to the baffles was generally confined to the baffles in the middle of the basin (3-7) with baffles 1, 2, 7, and 8 relatively undamaged. Reinforcing was exposed over approximately two thirds of the upstream face and partially around the corners of the baffles in the worst cases (Figure 140). All faces of the baffles had eroded to varying degrees. The toe of the spillway section was eroded to a maximum depth of 4 in. from the floor of the stilling basin up to approximately el 1192.5.

Figure 138. Erosion of stilling basin concrete, Kinzua Dam

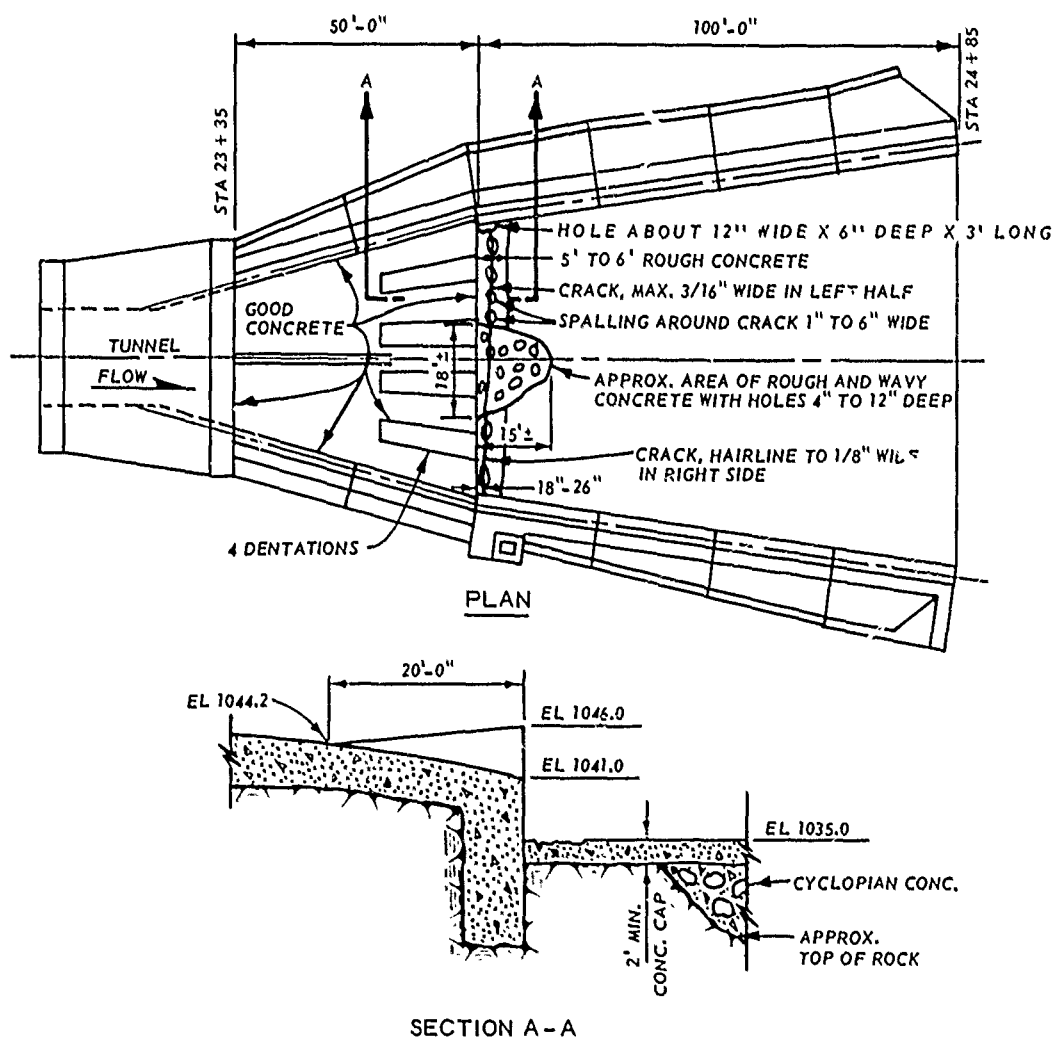
Figure 152. Results of 1975 stilling basin inspection, Tionesta Dam

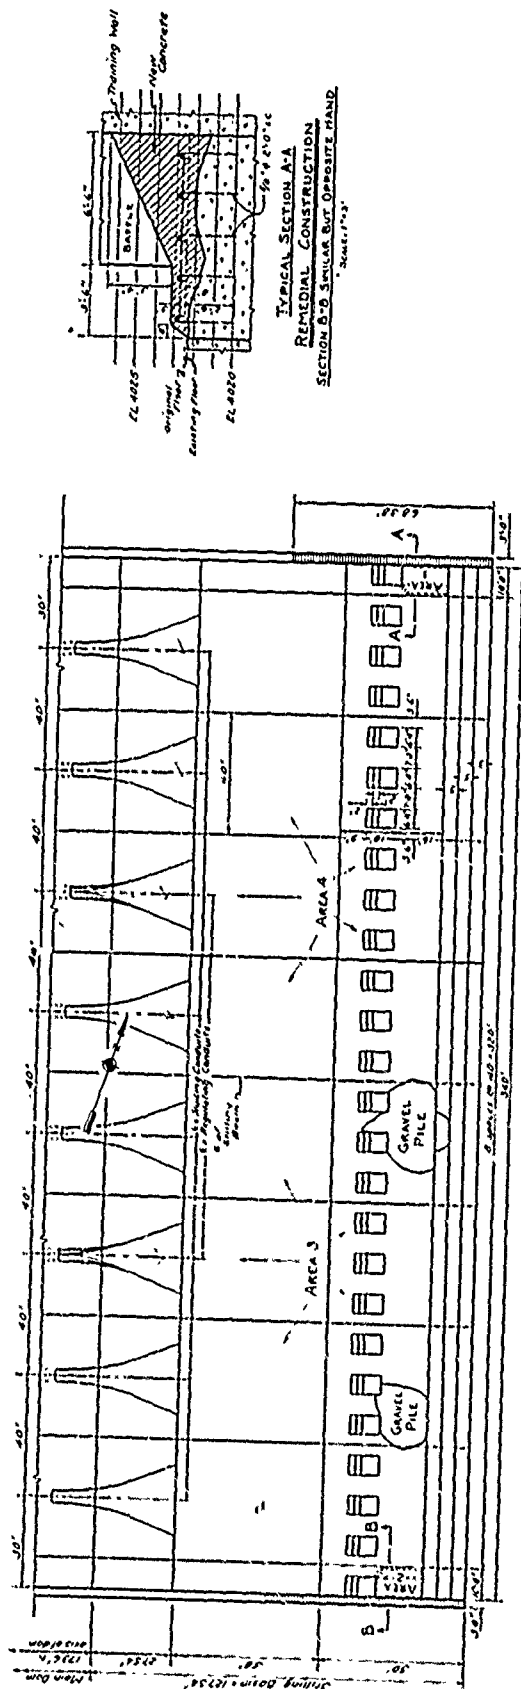
Figure 163. Stilling basin inspection and repair, Conchas Dam

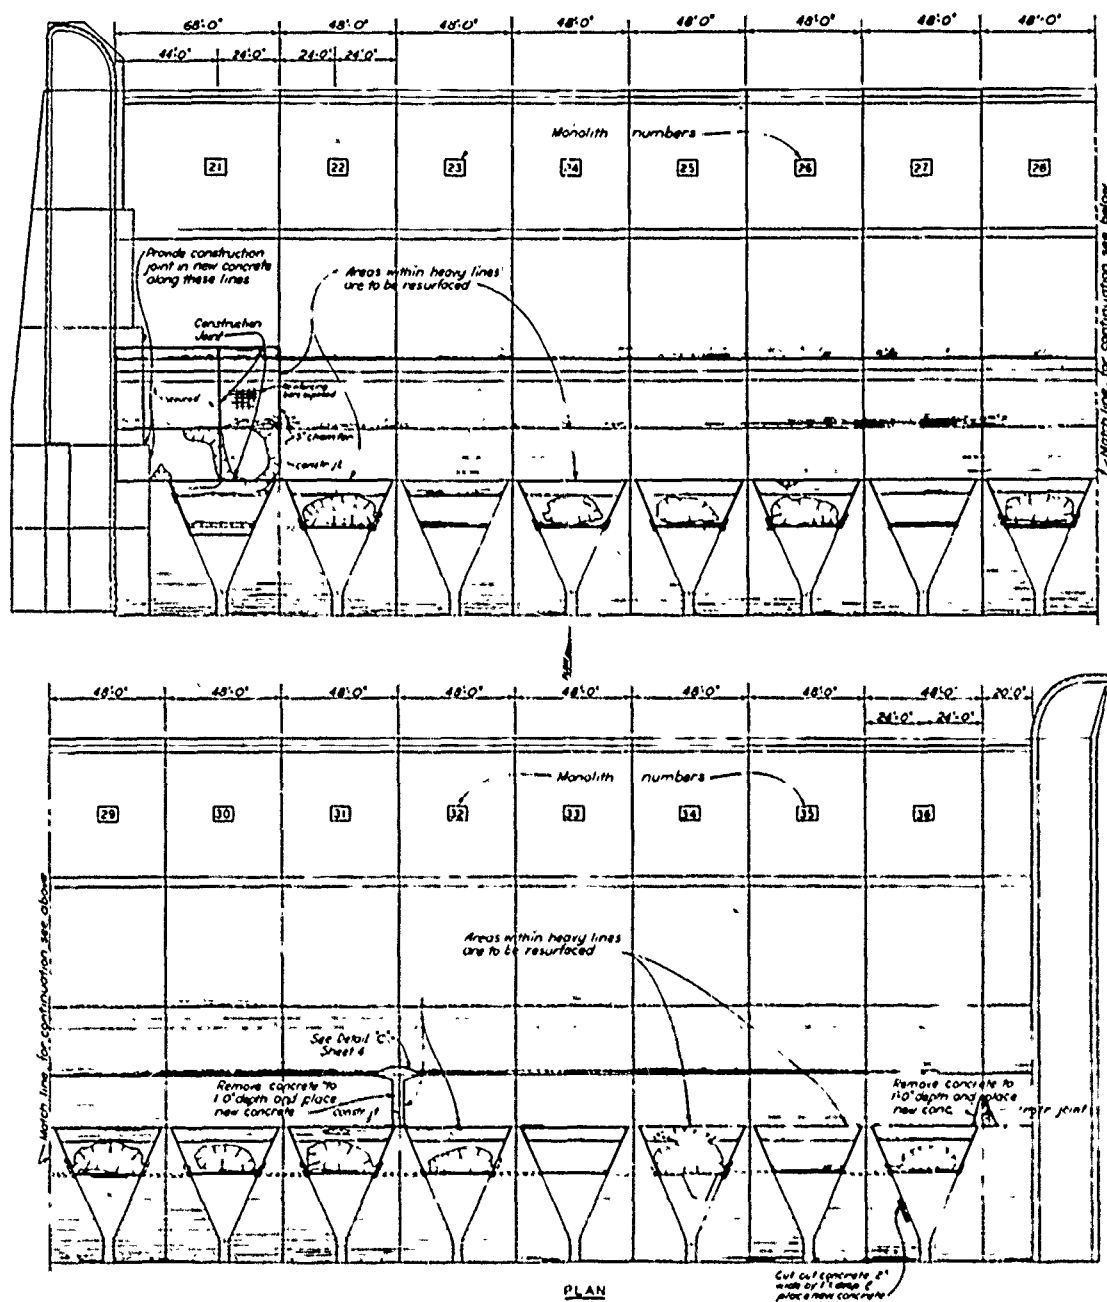
Figure 171. Areas of erosion and plan of repairs, Bull Shoals Dam (from Little Rock District 1953)
